TEST REPORT

Report No.: HC80278/2007
Page: 1 of 6
Date: September 5, 2007

Product Description: TEMWELL BRAND Helical Filter
Style/Item No.: 7H/ No.1
Manufacturer/Vendor: Temwell Corporation
Country of Origin: Taiwan
Quantity: Total 1 piece
Testing Period: Aug. 30, 2007
Note: (Client's declaration) The materials used for 7H series are similar.

1. Mechanical Shock Test

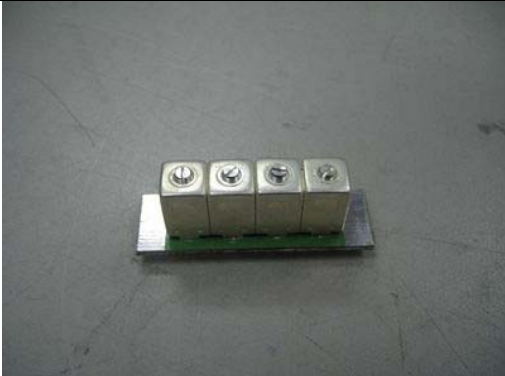
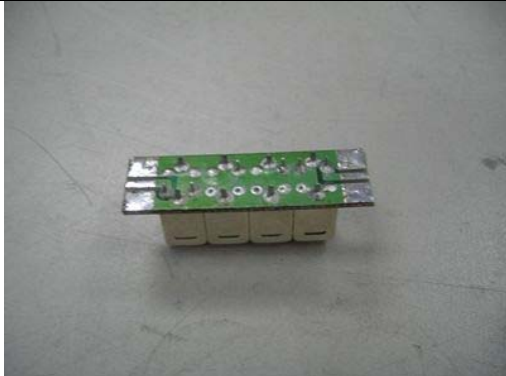
<p>1. Appearance of specimen-- 7H</p>	<p>2. Appearance of specimen-- 7H</p>

Check Item	Appearance check (Visual check)
Style/ Item No.	
7H/ No.1	No visible damage

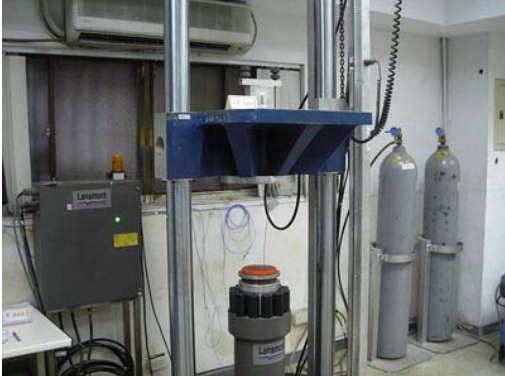
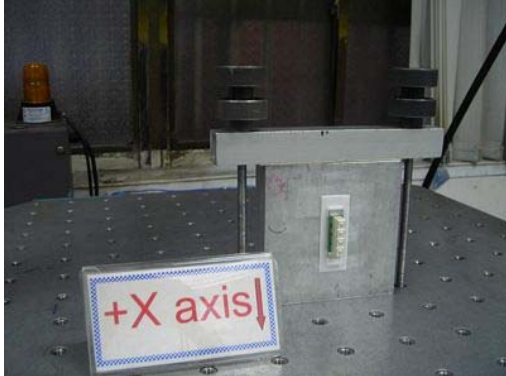
<p>3. Mechanical Shock Test: +X axis</p>	<p>4. Mechanical Shock Test: +X axis</p>

Shock direction: 6 faces (±X, ±Y, ±Z axes. See photo 3 ~ 14)

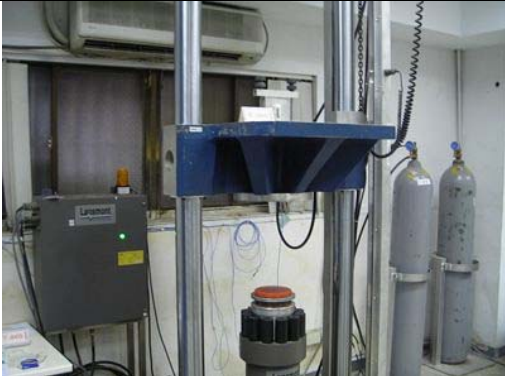
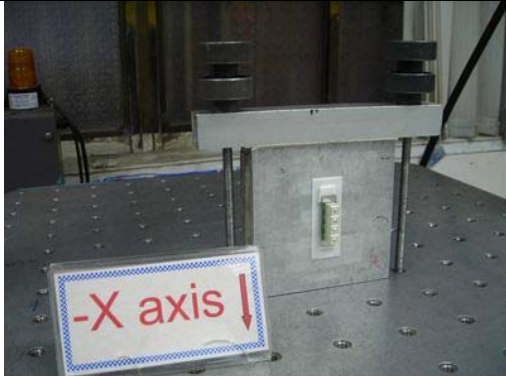
<p>5. Mechanical Shock Test: -X axis</p>	<p>6. Mechanical Shock Test: -X axis</p>

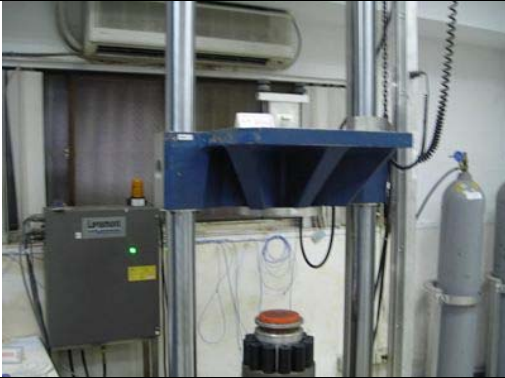
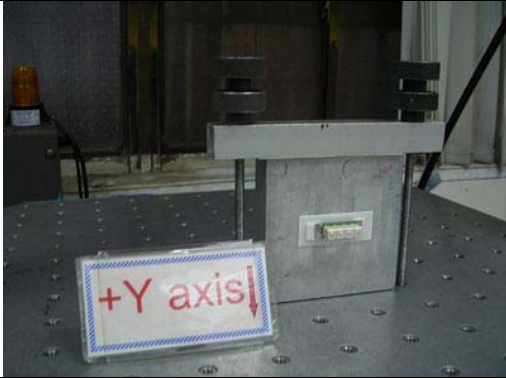
<p>7. Mechanical Shock Test: +Y axis</p>	<p>8. Mechanical Shock Test: +Y axis</p>

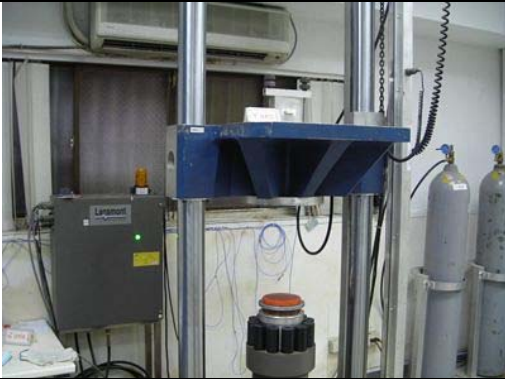
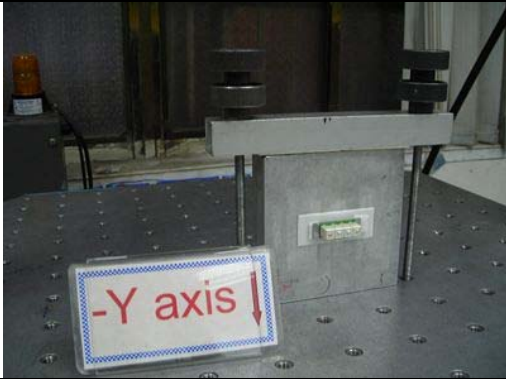
<p>9. Mechanical Shock Test: -Y axis</p>	<p>10. Mechanical Shock Test: -Y axis</p>

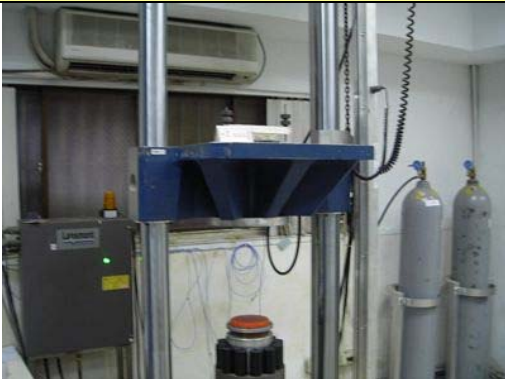
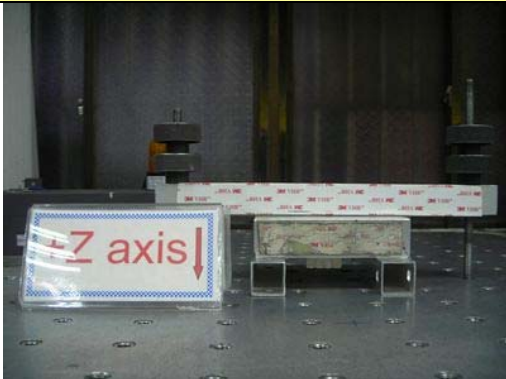
<p>11. Mechanical Shock Test: +Z axis</p>	<p>12. Mechanical Shock Test: +Z axis</p>

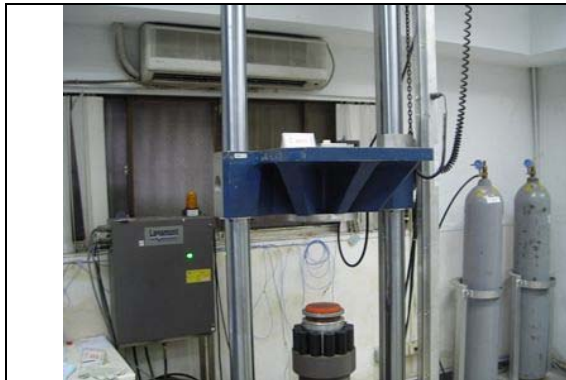
13. Mechanical Shock Test: -Z axis

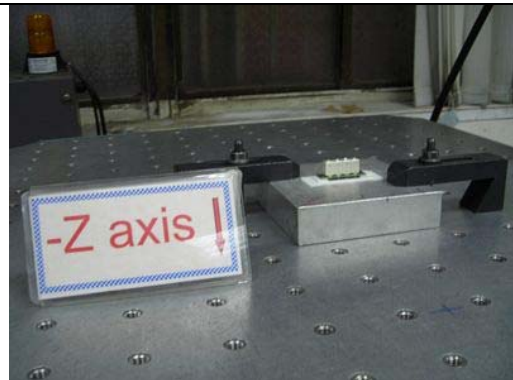
14. Mechanical Shock Test: -Z axis
